Customer Inspectors

Empty Property Inspection June 2009

Report by
Hannah Fitzhenry
Customer Insight Officer

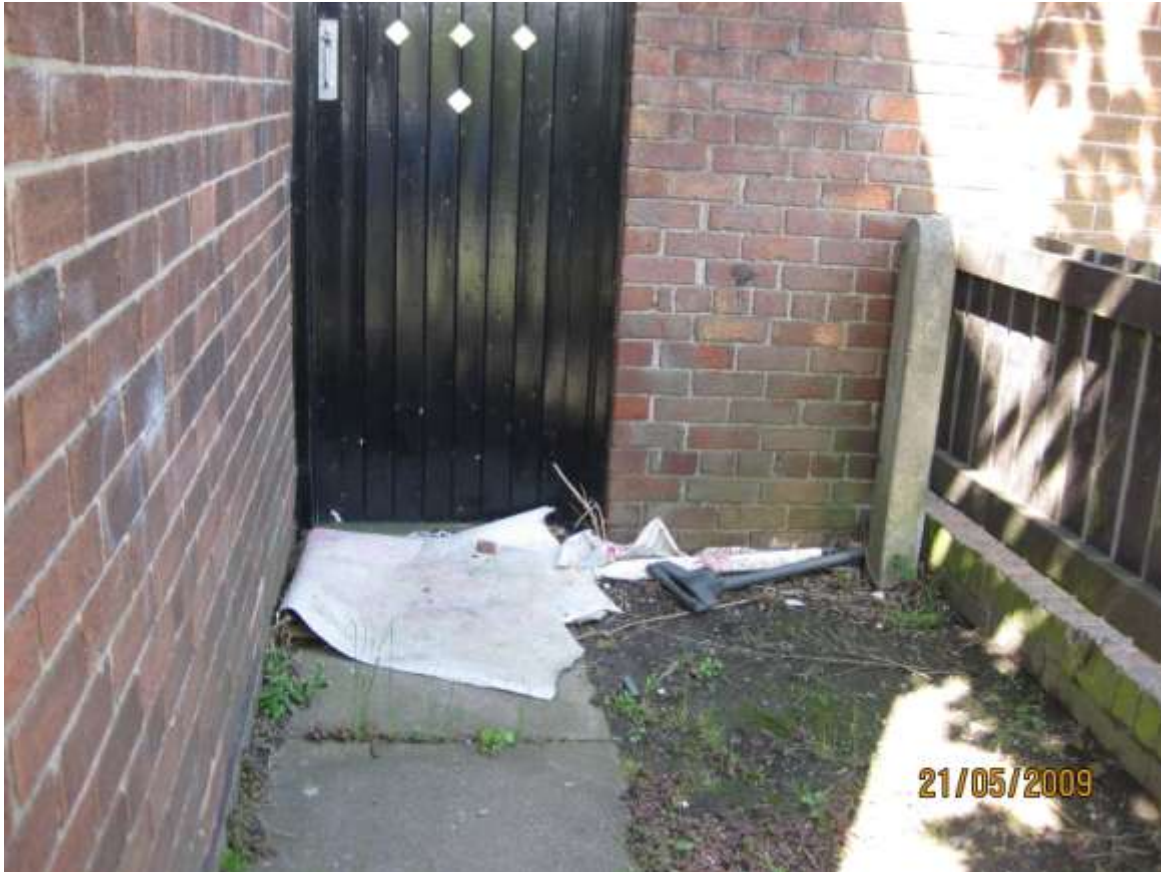
“lots of tipping from residents and workers, rubbish.”

The photograph below illustrates some rubbish that has been left in the external areas of 20 York Close,

Recommend that photos be taken when workmen have cleared the rubbish up then will know if fly tipping is taking place.

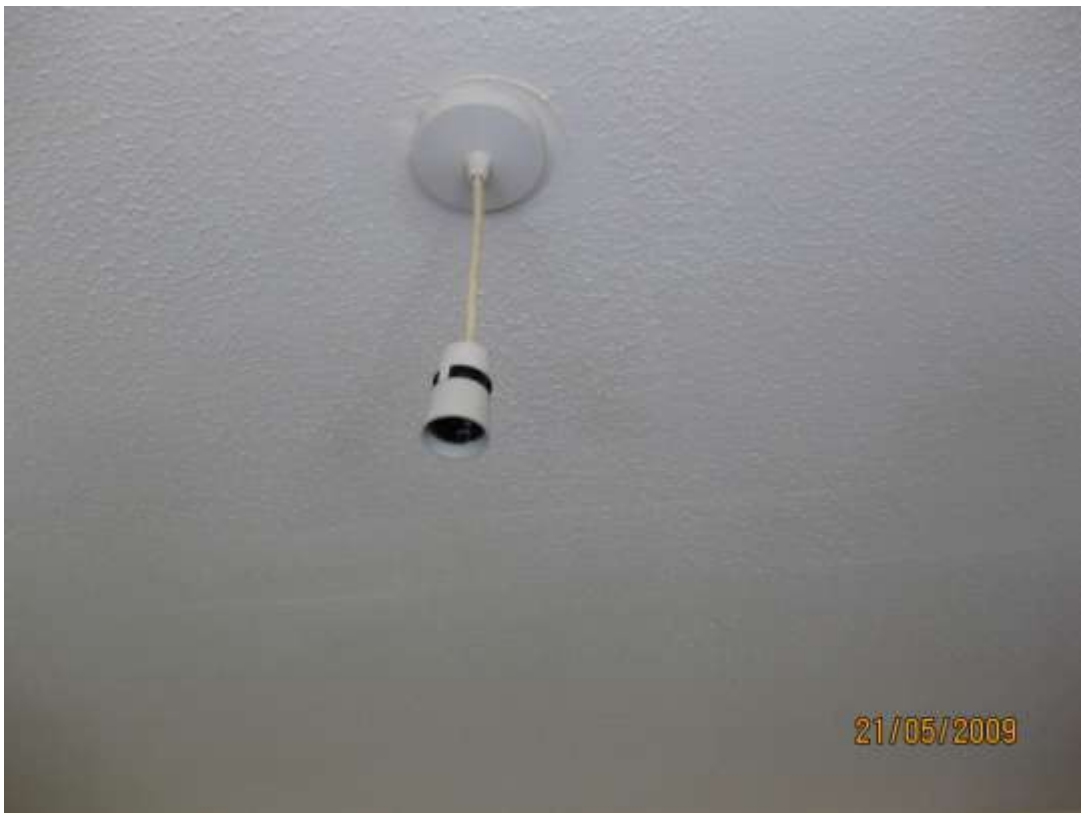
The photograph below shows an example of a light fitting where no low energy light bulb has been fitted. The photograph was taken at 8 Adelaide Close.
