Customer Inspectors

Empty Property Inspection June 2009

Report by
Hannah Fitzhenry
Customer Insight Officer

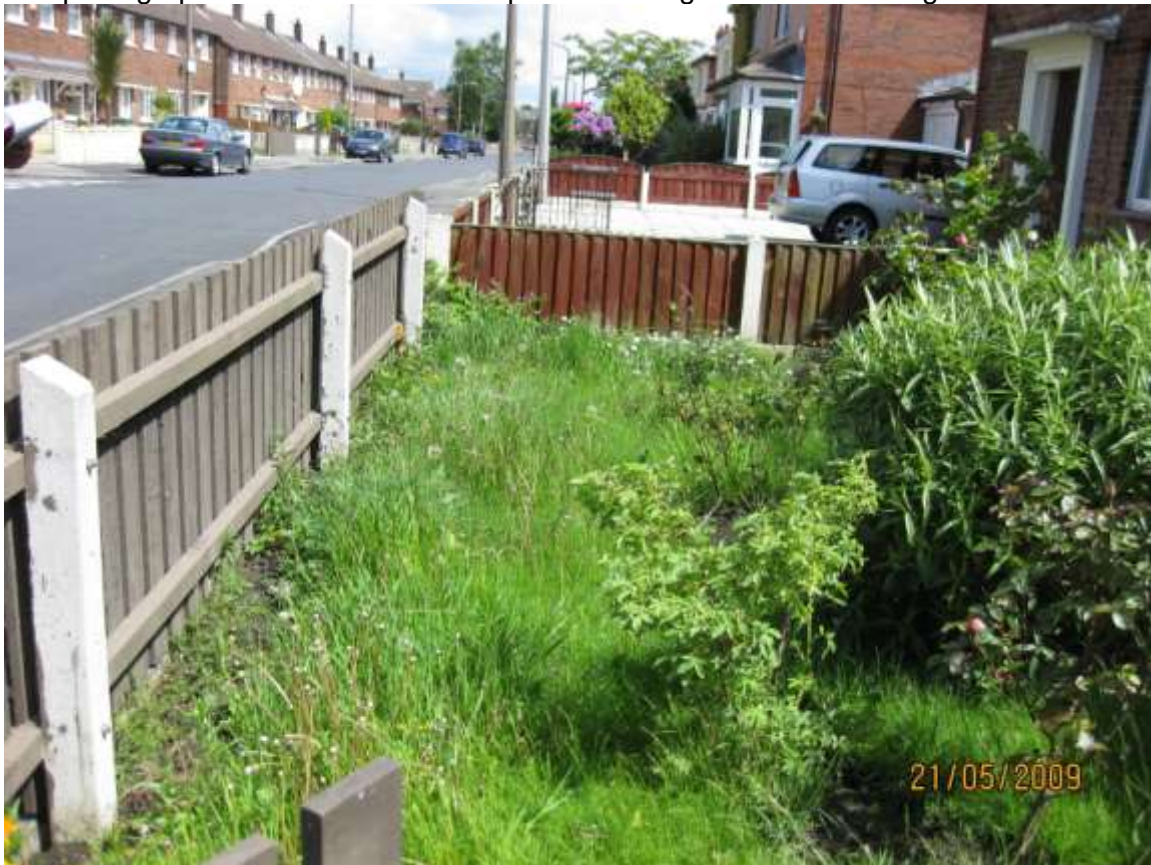
“Garden needs to be cut back and pruned”

The photograph below shows an example of a front garden that is overgrown.

“Gardens and open spaces: recommend that they are tied up and rubbish removed the week before the keys are handed over.

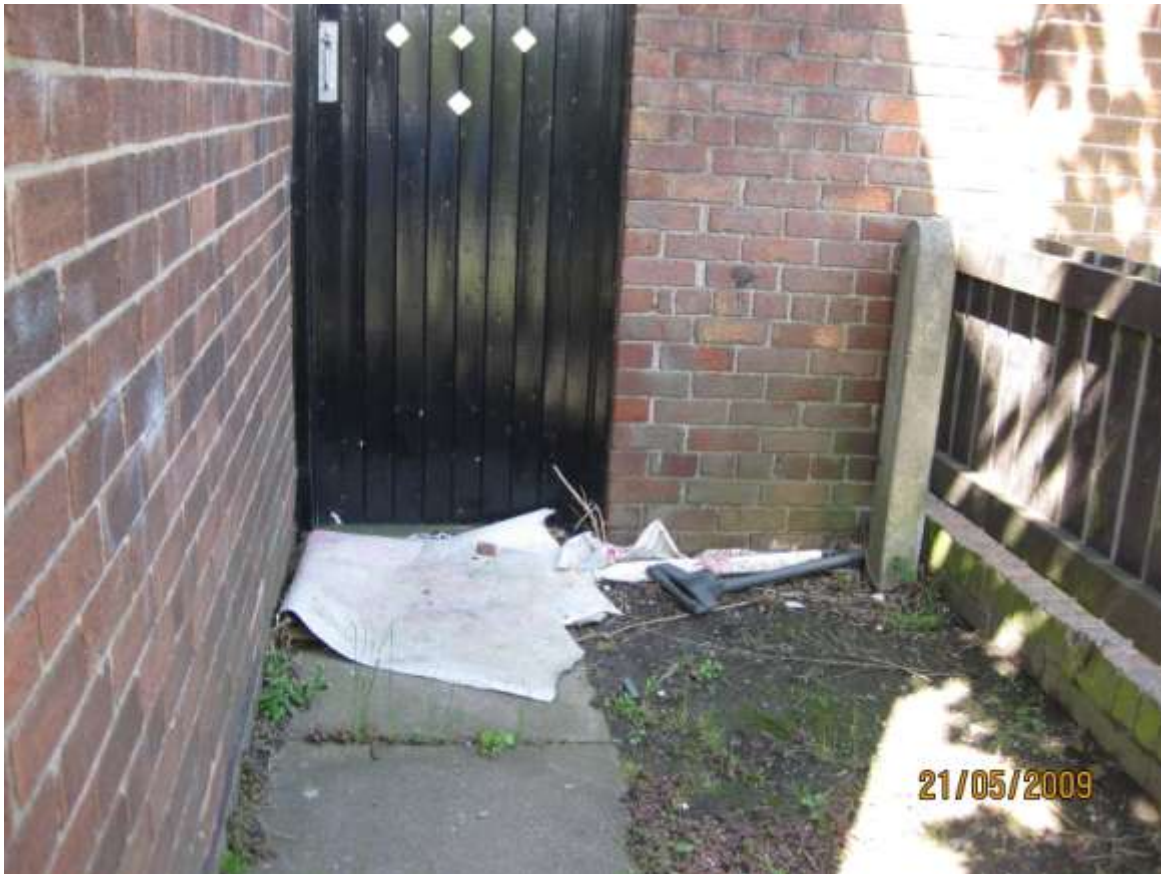
“lots of tipping from residents and workers, rubbish.”

The photograph below illustrates some rubbish that has been left in the external areas of 20 York Close,

Recommend that photos be taken when workmen have cleared the rubbish up then will know if fly tipping is taking place.

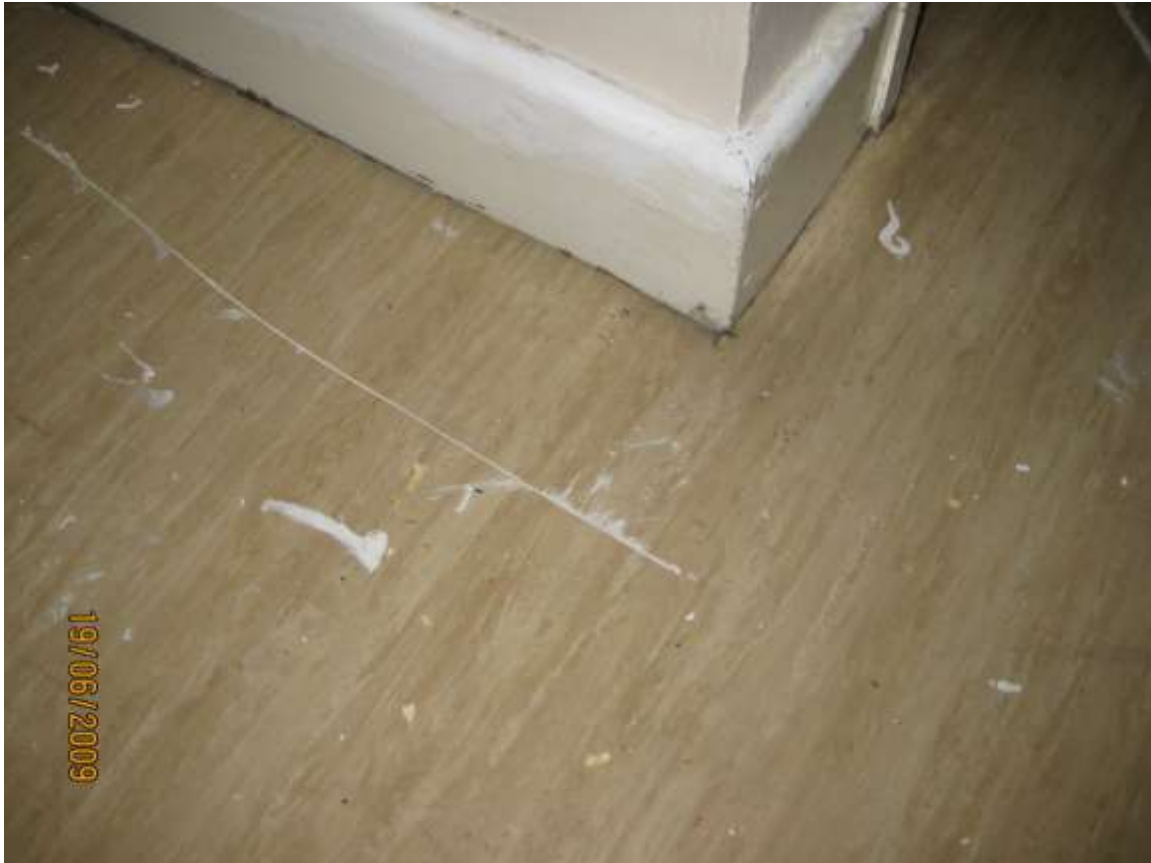
Below is a photograph that shows an example of a floor that has not met the standard. The photograph is taken in the Living Room of 6 Cross Meadow Court, Peasley Cross.

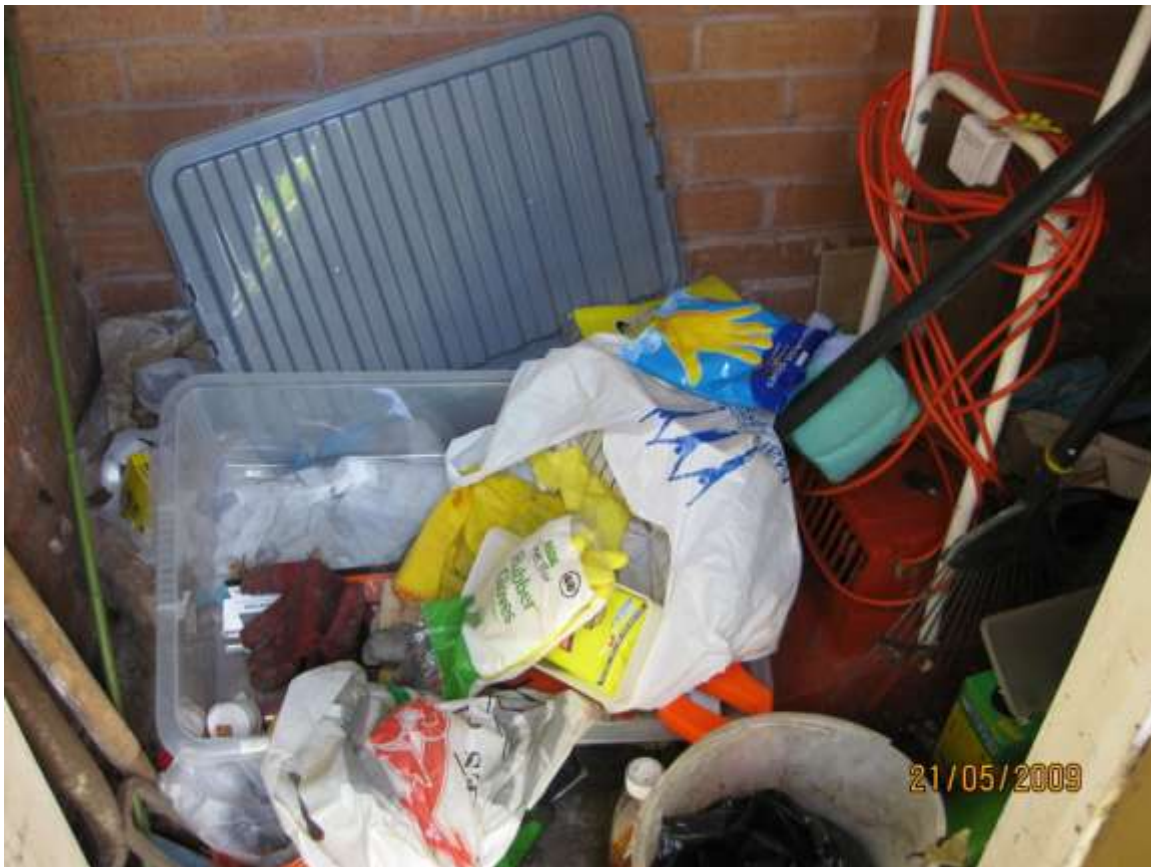
There was one occasion when a storage area in a property clearly did not satisfy the standard, this was in 5 Adelaide Avenue.

The photograph below supports that the external storage area in 5 Adelaide Avenue was not free from rubbish.

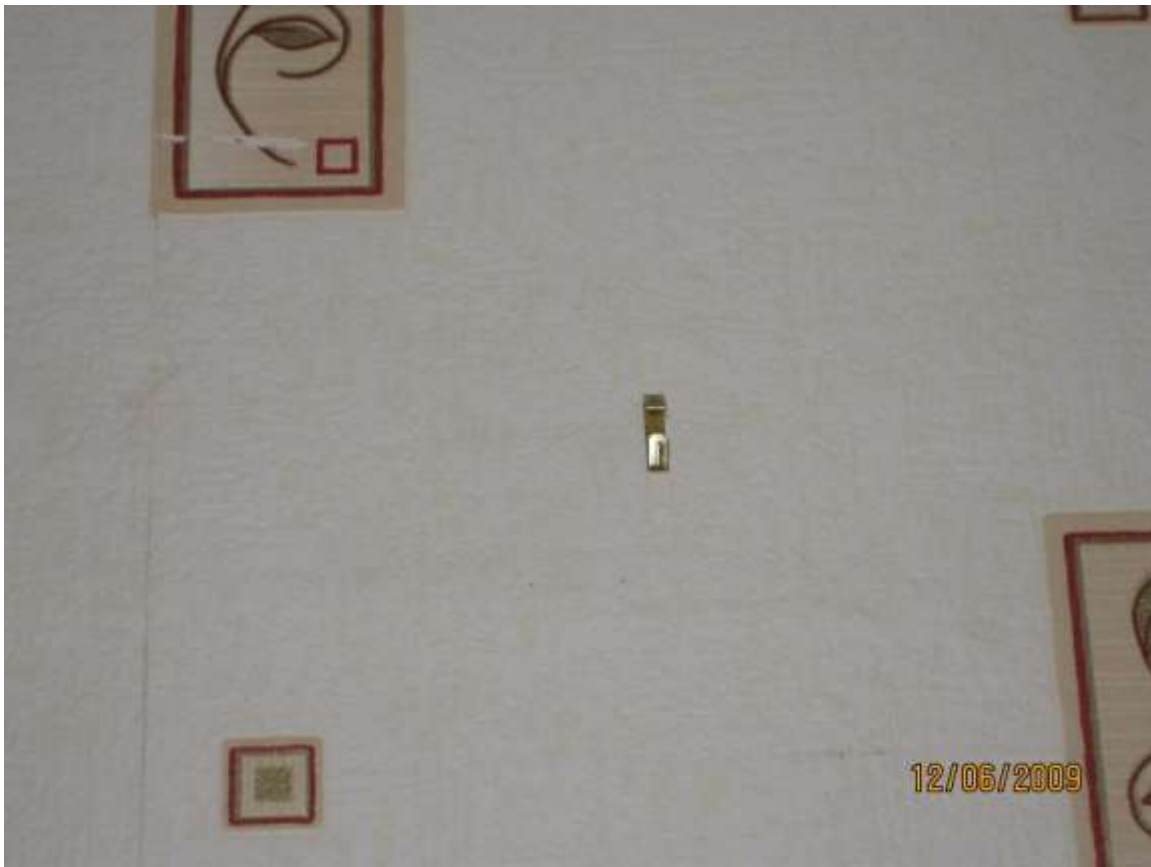
The photograph below shows an example of where this standard was not met. The photograph was taken in the Living Room of 30 Gloucester Street.

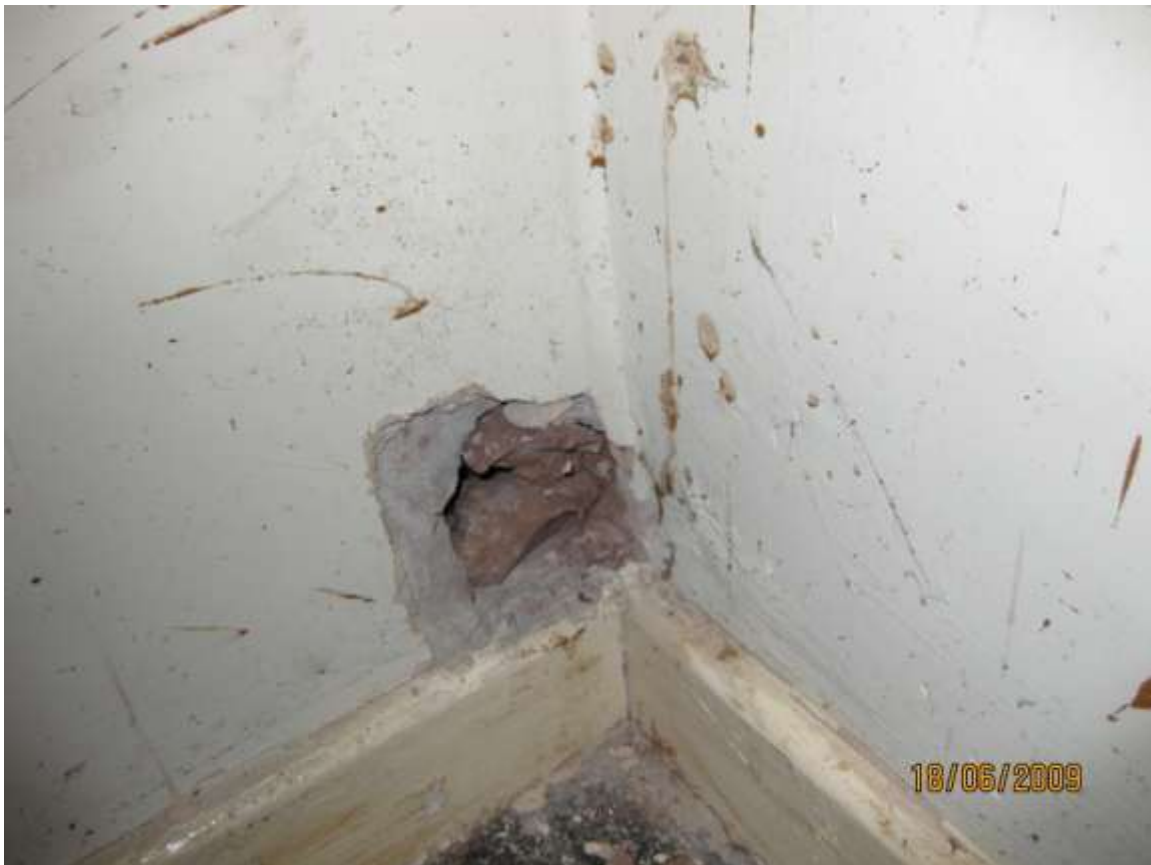
A number of comments were about the conditions of the walls at 20 York Close, they highlight the need to improve the condition of the walls to improve the standard of the property.

“... wallpaper hanging not nice to see plus cracks should have been fixed by now.”

Below is an example taken from 20 York Close showing where the Customer Inspectors were not satisfied that the walls have been left ready to decorate.

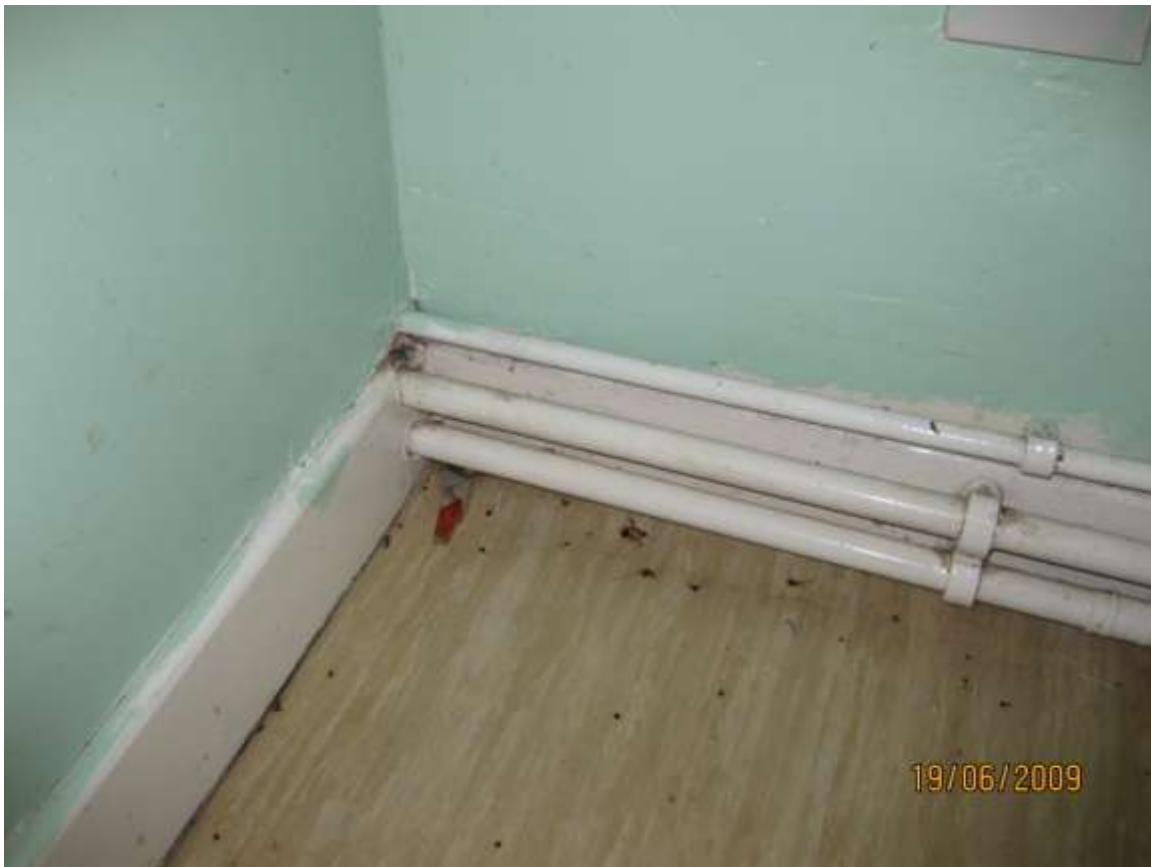
“skirting old and battered”

The photograph below shows a skirting board that has not met the standard, it was taken at 6 Cross Meadow Court.

Woodwork: such as skirting and door casings to be fully replaced when looking battered as there was sharp contrast between new areas such as new kitchens and bathrooms.

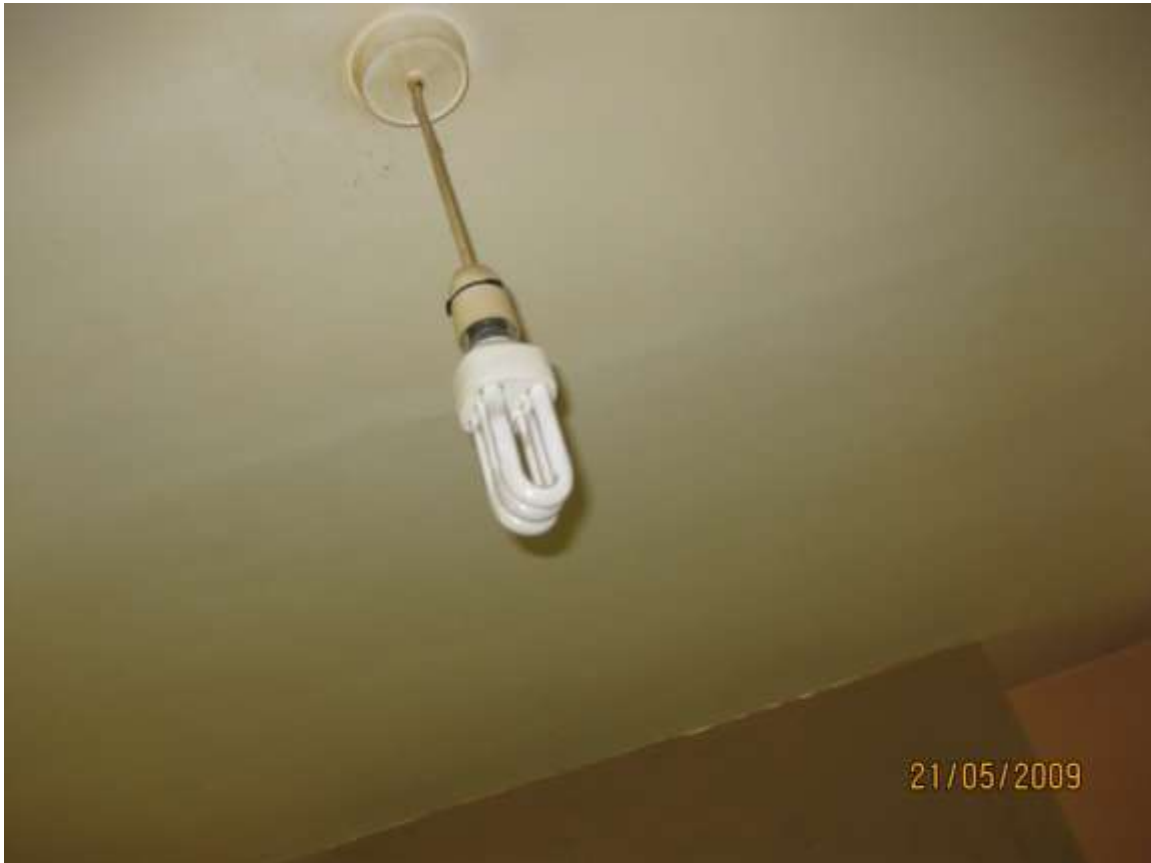
“yellow and dirty”

The photograph below supports the comment above, where the standard was not satisfied at 8 Martin Avenue.

“Old and discoloured light fittings and switches could be replaced rather than trying to clean them.

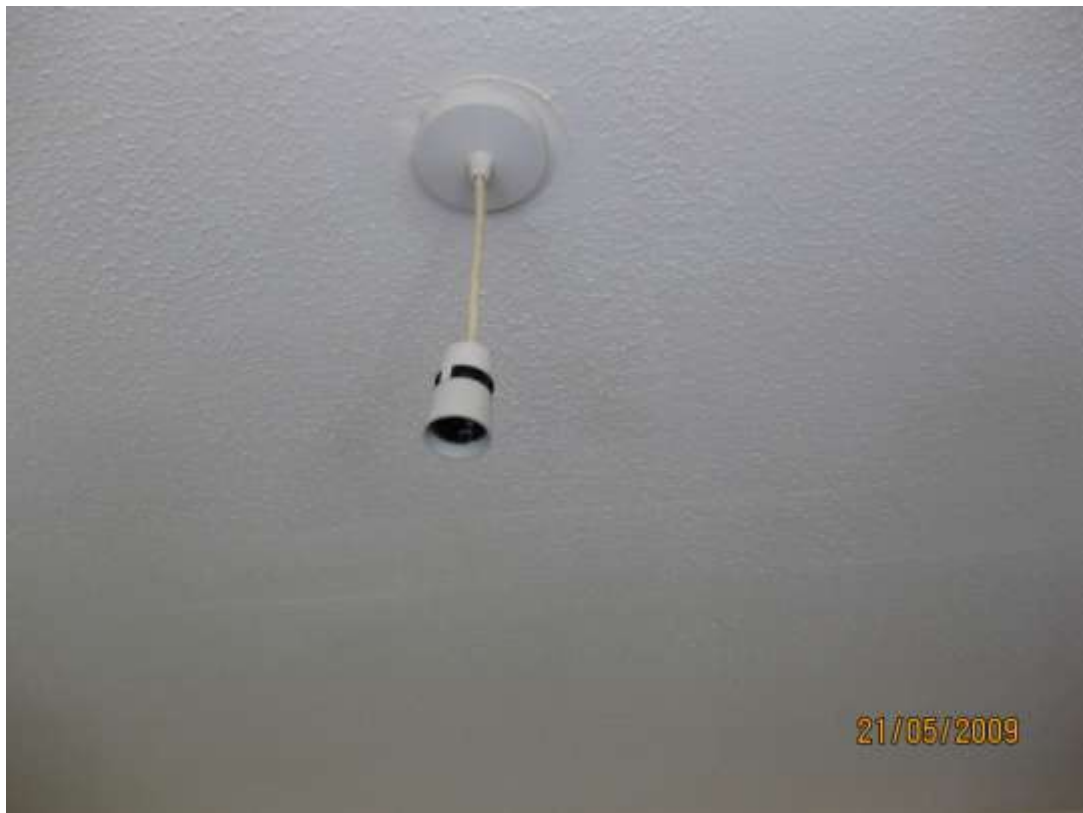
The photograph below shows an example of a light fitting where no low energy light bulb has been fitted. The photograph was taken at 8 Adelaide Close.

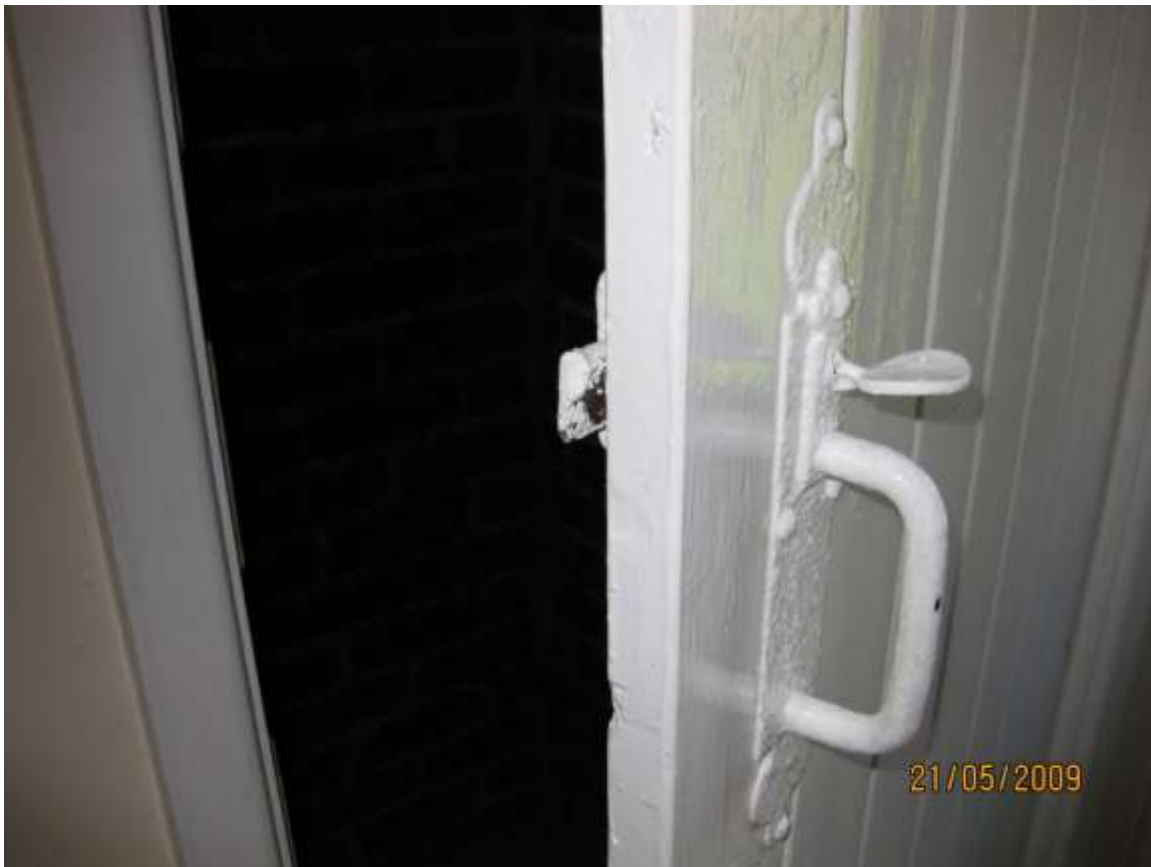
The photograph below highlights a door which does not close properly, it was taken in the Kitchen of 8 Martin Avenue.

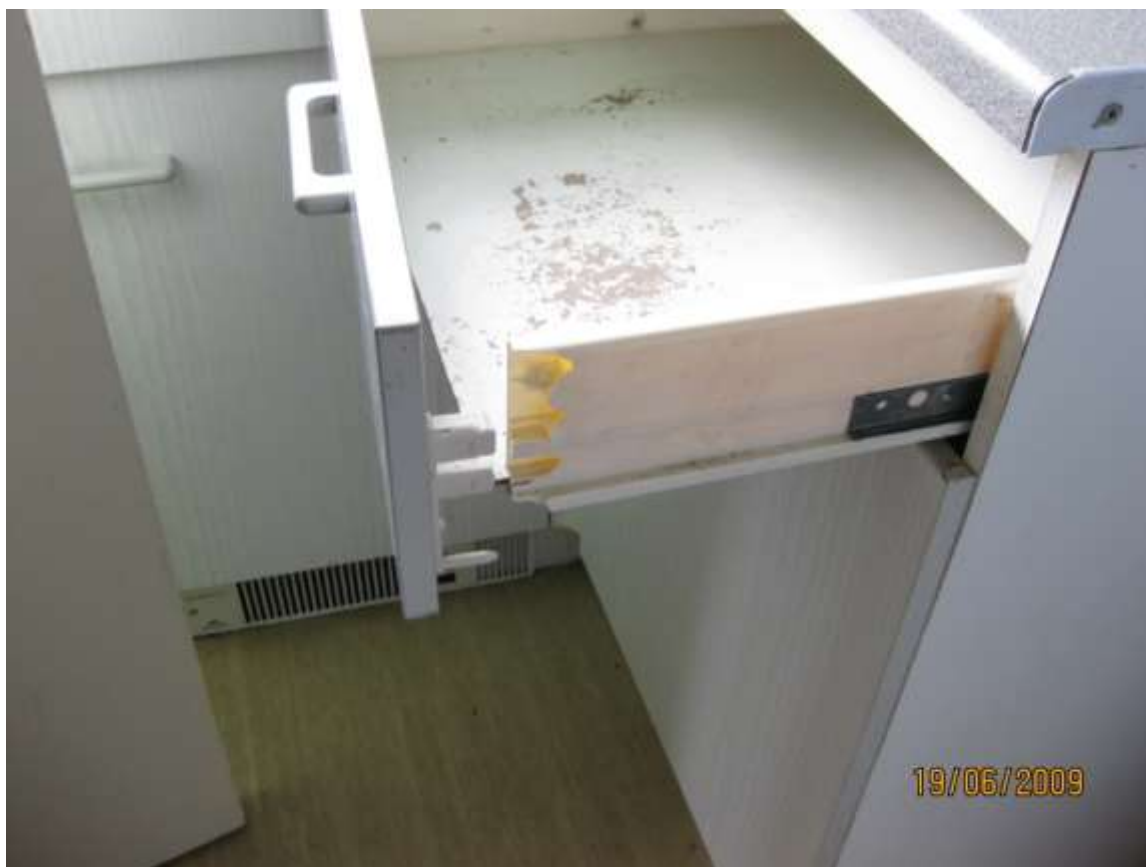
There were two cases where the kitchen failed to meet the standard, this was at 6 Meadow Cross Court and 190 Oak Avenue.

The photograph below shows the broken draw from 6 Meadow Cross Court.

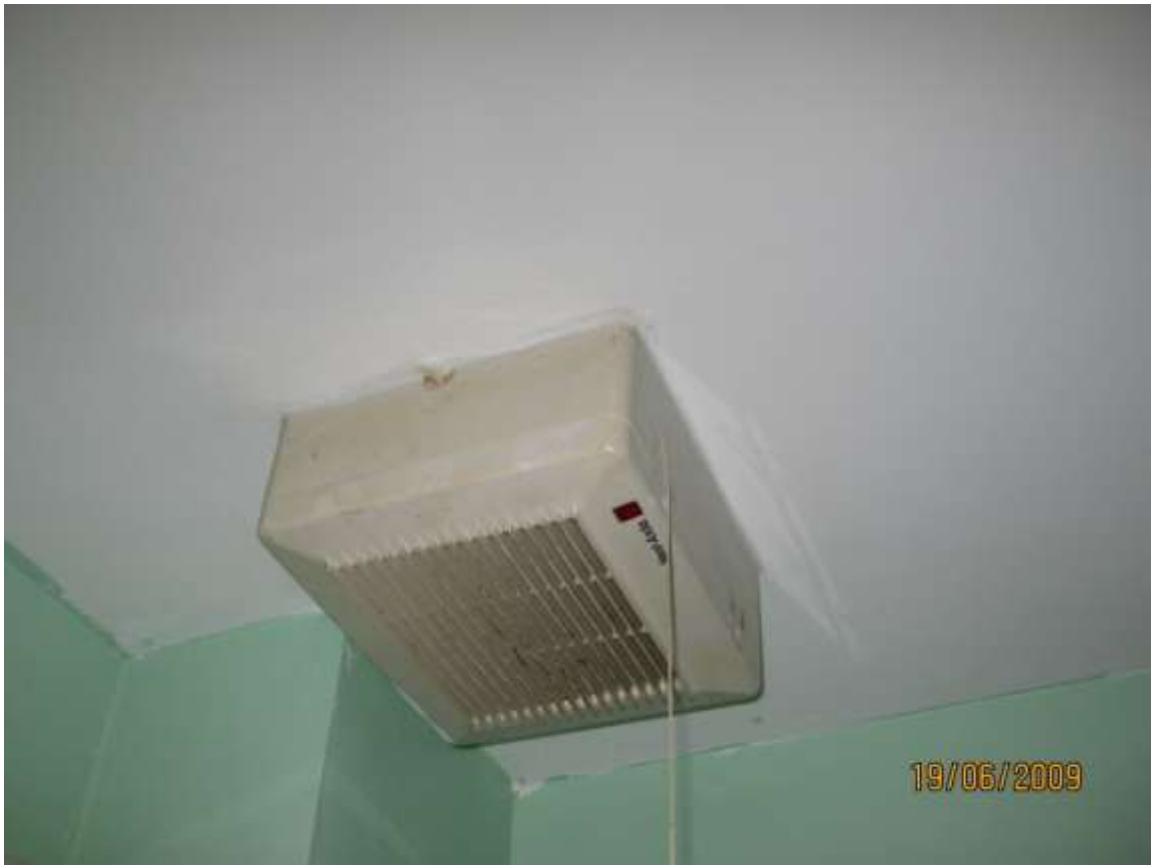
The photograph below displays an extractor fan from 6 Cross Meadow Court that is not clean and free from dust.

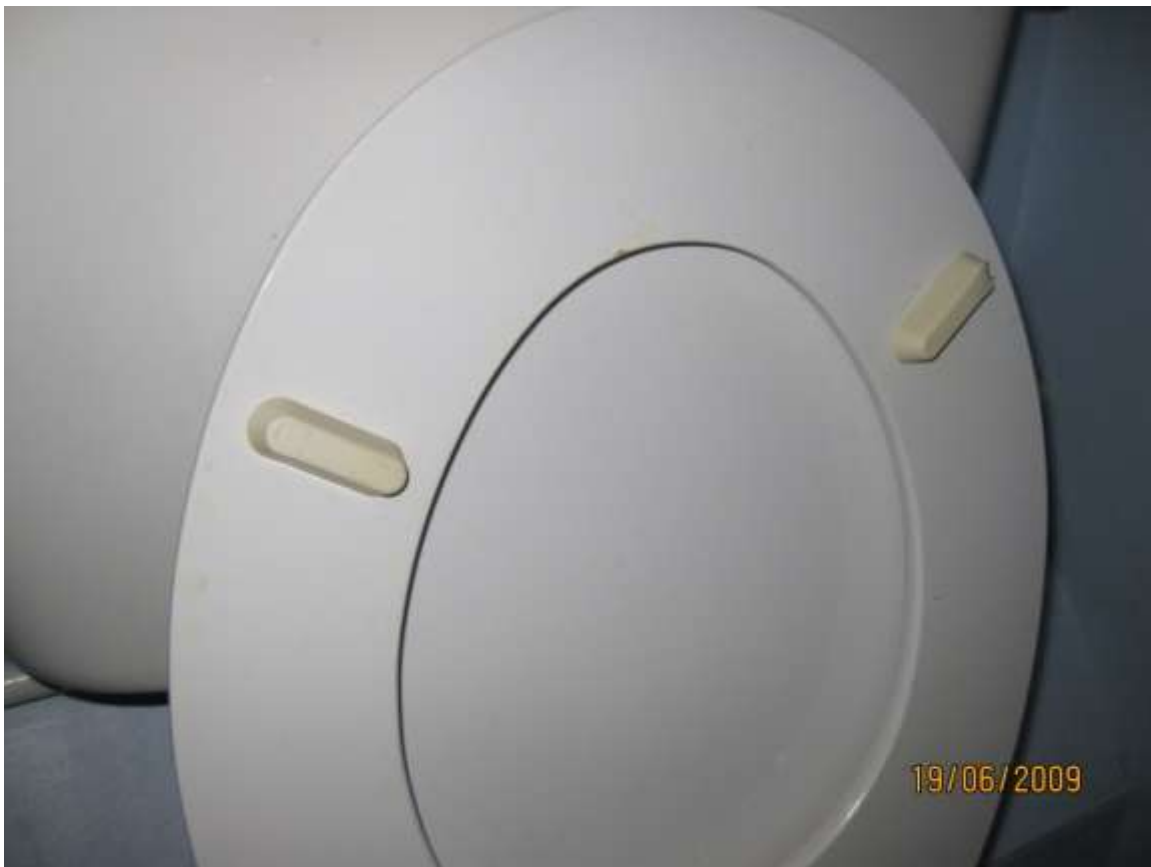
The photograph below was taken in 6 Cross Meadow Court where the Customer Inspectors highlighted it as not meeting the standard.

Toilet seats replaced before let”

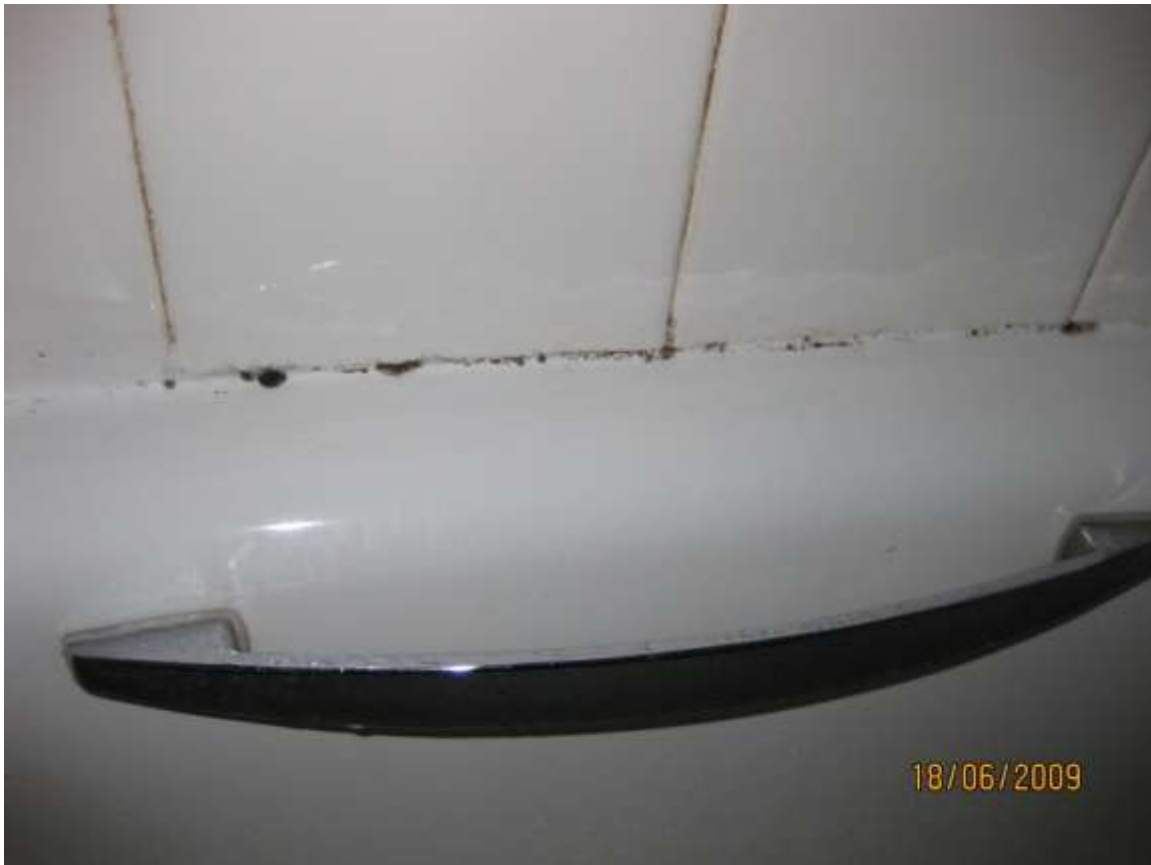
This standard was satisfied by all but one of the inspected properties. This was in 238 Earle Street where the sealant has mould.

The photograph below highlights the silicon sealant that was not in good repair at 238 Earle Street.

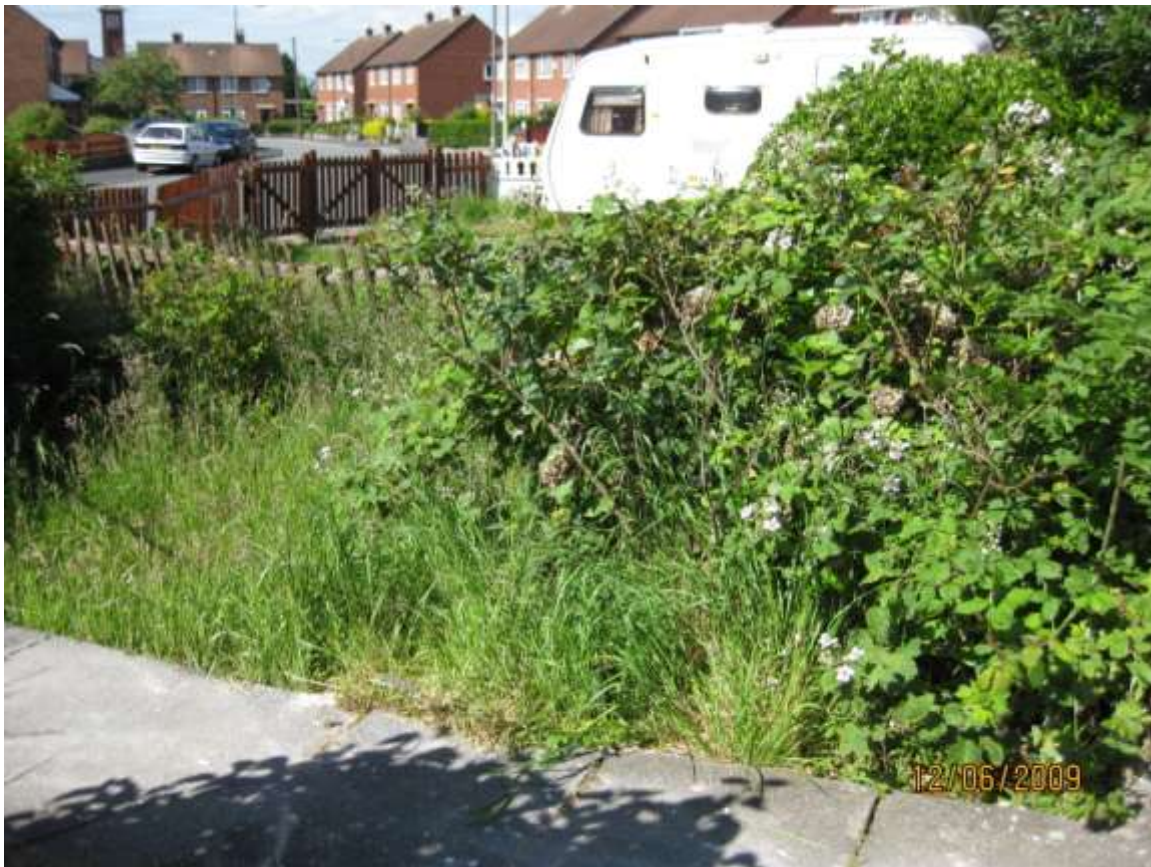
“...grass very overgrown, shed full of rubbish etc. can't see the slates of the roof.”

The photographs below show examples of untidy gardens at 56 Siddeley Drive.

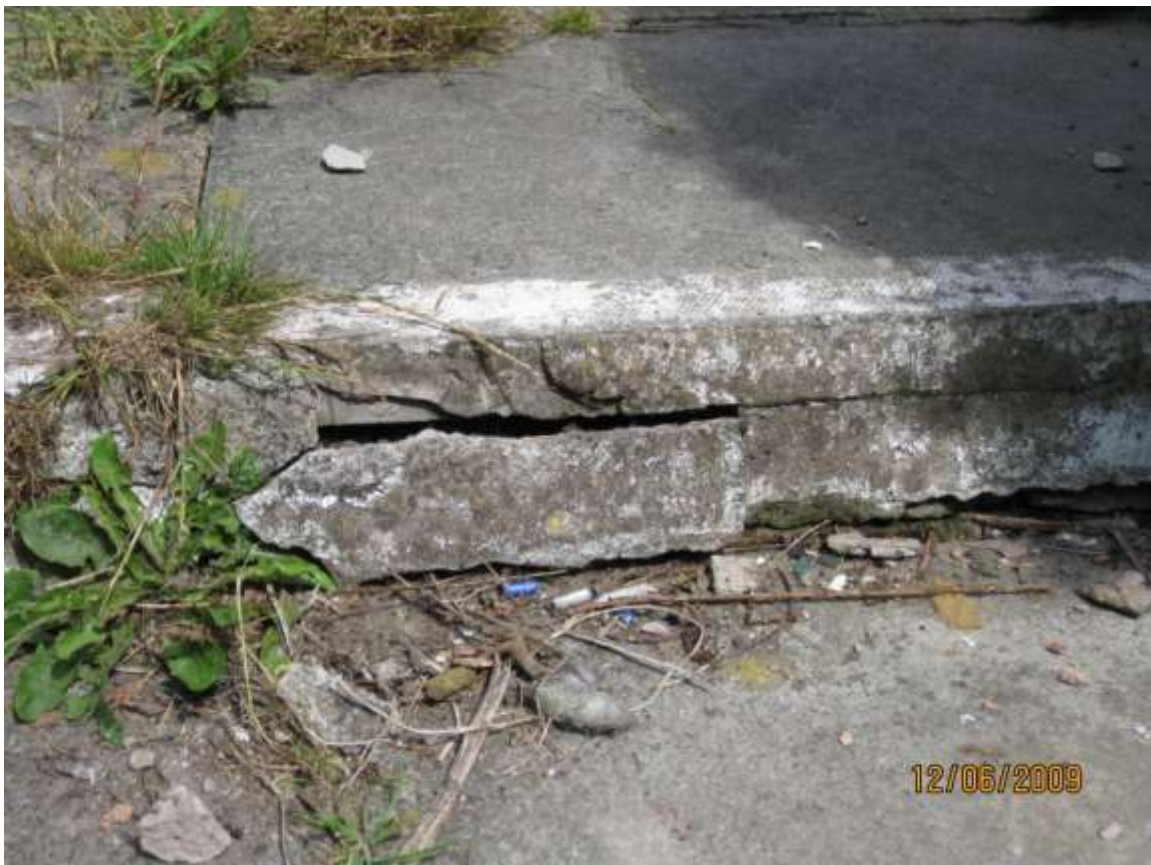
The photograph below shows an example of a trip hazard at 30 Gloucester Street.

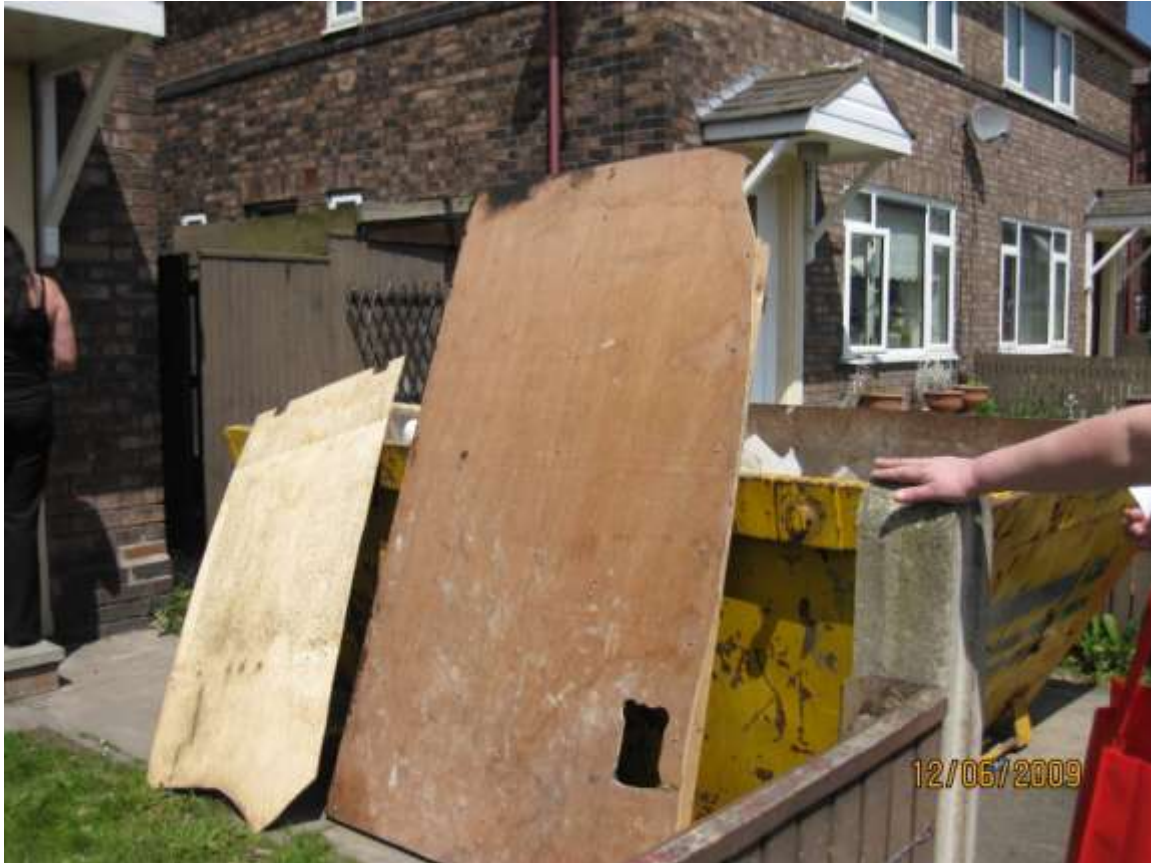
The photograph below also shows an example of a trip hazard left in the front garden of 30 Gloucester Street.

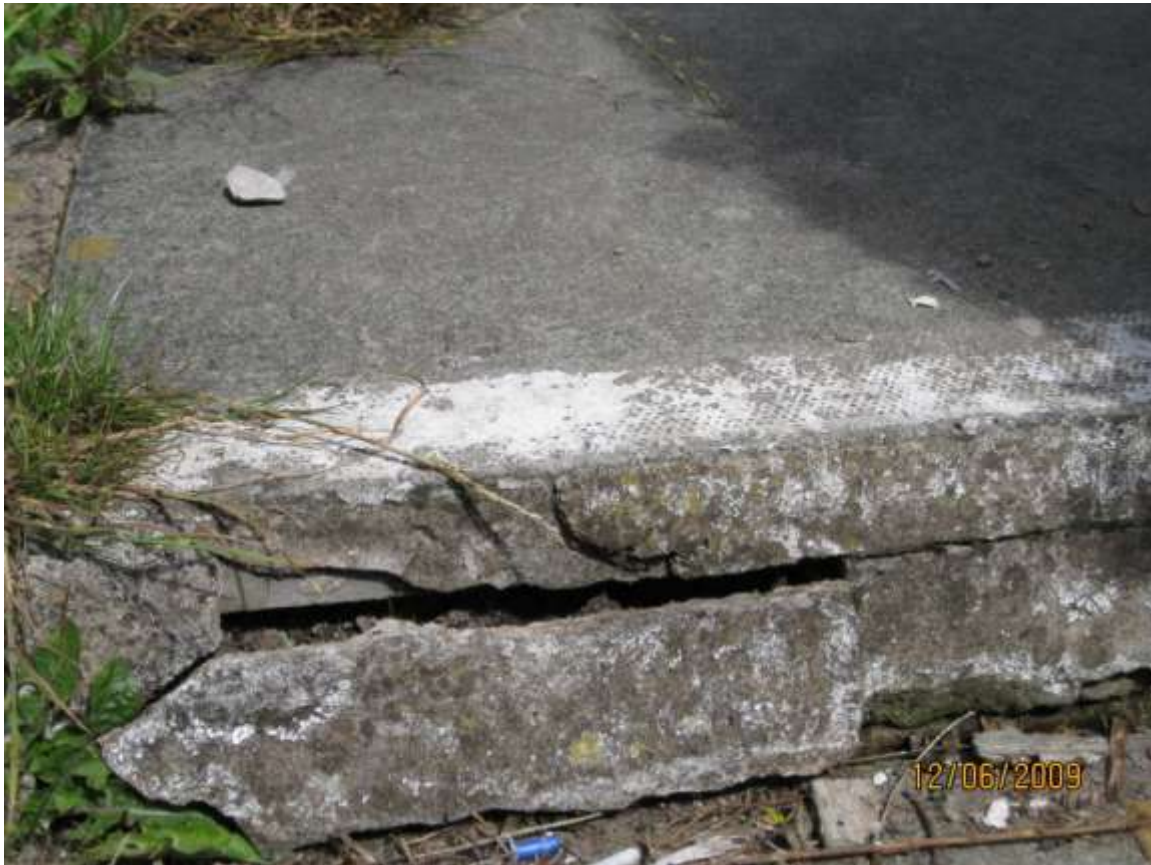
The majority of the properties inspected satisfied this standard. The only property that failed to satisfy the standard was 30 Gloucester Street,

The photograph below highlights the broken step at 30 Gloucester Street.

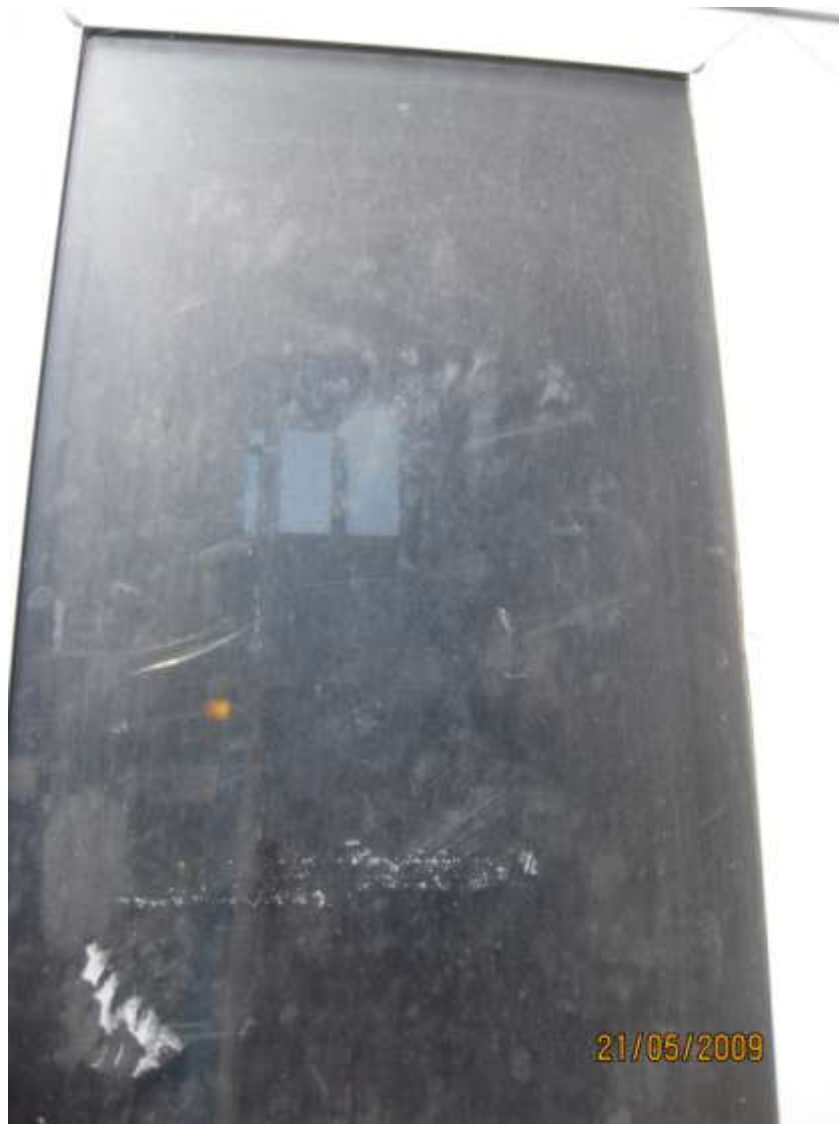
“Window sills not clean”

The photograph below shows an example at 8 Martin Avenue where the window has not been washed and cleaned.

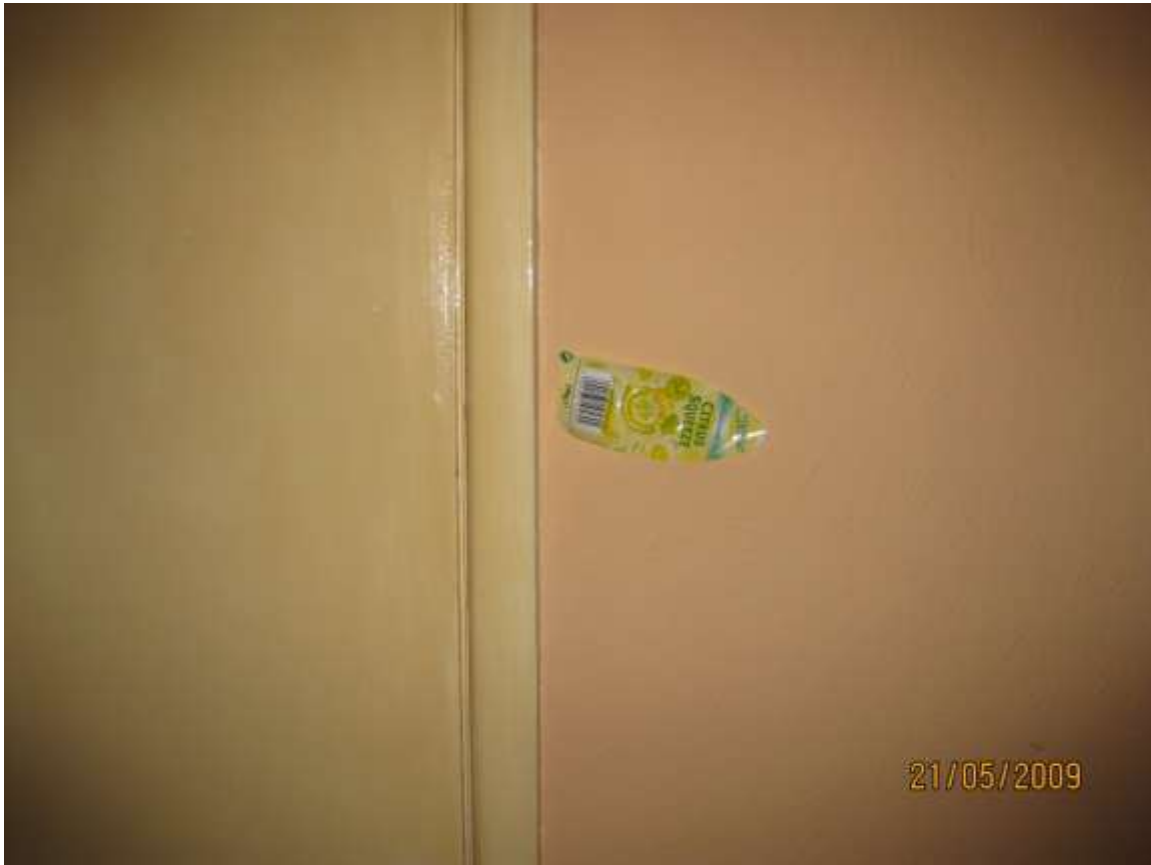
In 8 Martin Avenue the Customer Inspectors found an incident where the sticker from the air freshener had been stuck to the wall of the property and had not been cleared with the rest of the rubbish from the property.
